## Home Inspection Report

9776 Heavenly Lane, Mequon , WI 53092

Saturday, March 10, 2018

200204

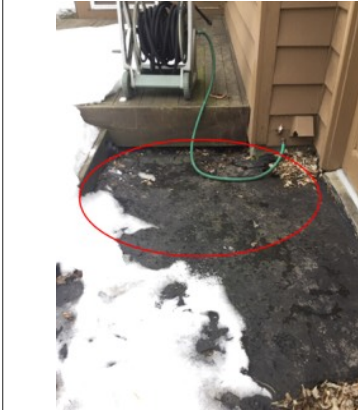
Depression in asphalt creates a negative slope for water runoff, recommend improving as needed

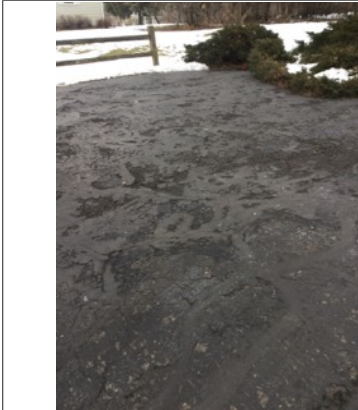
Minor cracks were observed in driveway which may indicate soil settlement - typical for age of home, recommend routinely sealing all cracks and exposed areas as needed to prevent seasonal freeze/thaw deterioration, future movement and prolong the driveway's useful life.

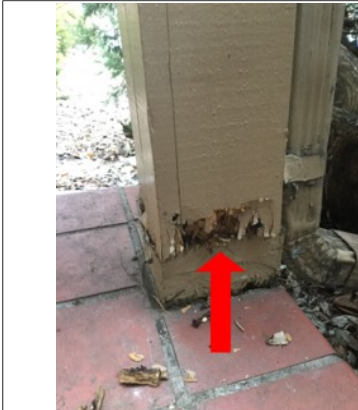
East supporting post has wood rot and was loose to base, recommend a qualified contractor replace as needed.

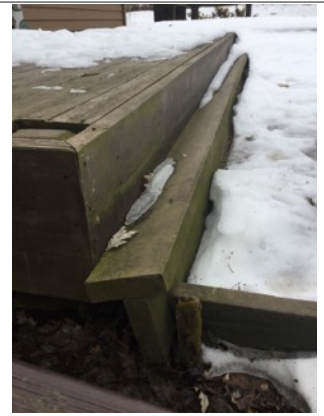
Steps to deck were tilted creating potential trip hazards, recommend replacing as needed.

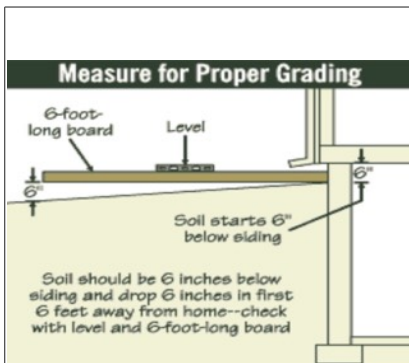
Some areas around the house were flat and/or negative increasing the risk of water intrusion, recommend adding additional soil to create a positive slope for proper water runoff.

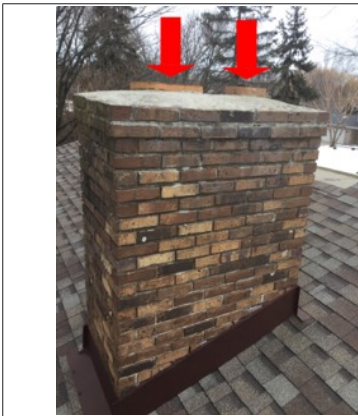
Chimney flues are recommended to be covered with a rain cap to prevent water from entering the chimney, potentially causing damage to brickwork and entering the home's attic and causing subsequent damage to interior walls/ceilings. When used in conjunction with a fireplace, flue covers can stop down drafts - preventing the home from filling with smoke and prevent cold blasts of air, in-turn helping to improve the home's energy efficiency. When a mesh or screen is integrated with the flue cover, it becomes a deterrent for animals (birds, squirrels, raccoons, etc.) from nesting within the warmth of the chimney.

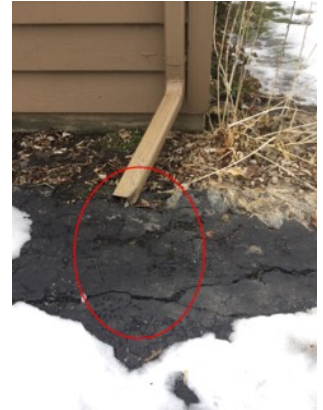
Downspout directs roof water onto asphalt path creating seasonal icing conditions and premature wear, recommend improving

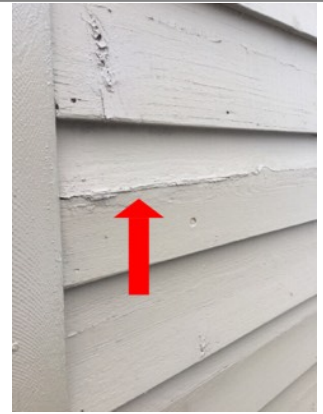
Split wood siding, recommend replacement

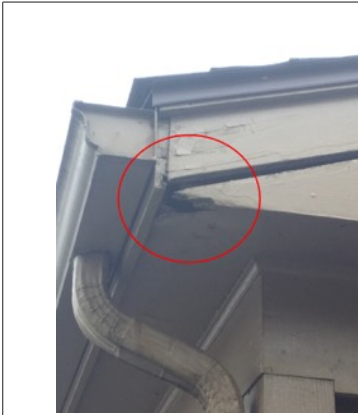
Damaged wood trim and fascia at gutter end, recommend sealing internal gutter and replacing all damaged wood.

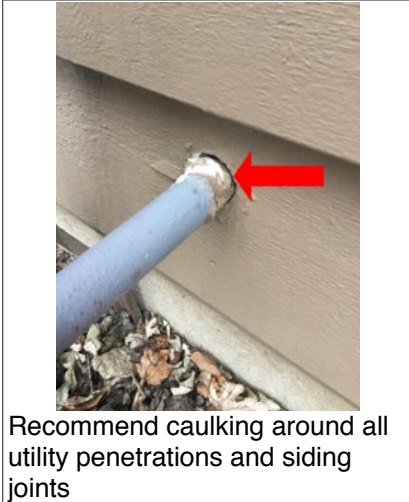
Recommend caulking around all utility penetrations and siding joints

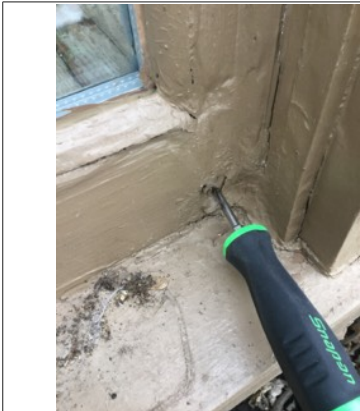
Wood rot on north side of house

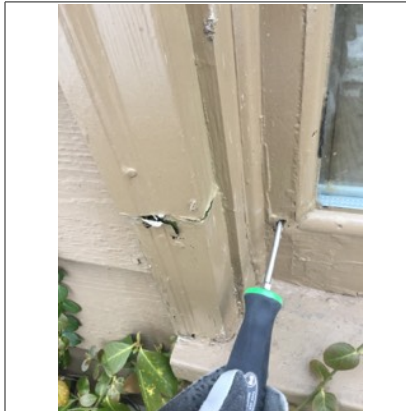
Wood rot on north side of house

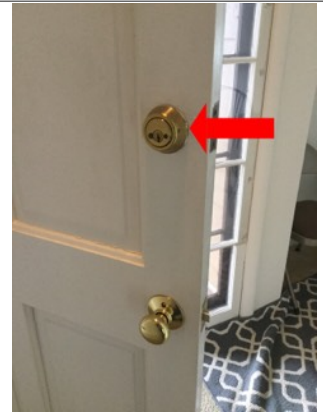
Keyed locks from the interior can pose a risk of entrapment in an emergency. No special tools or knowledge should be needed to exit the home in an emergency. A thumb latch deadbolt is the recommended replacement.

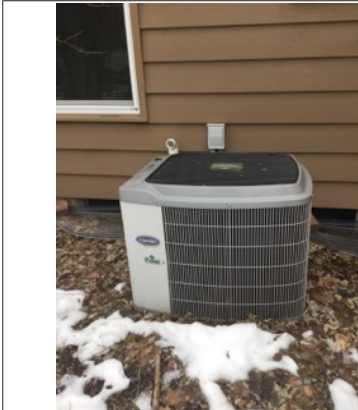
Air conditioning unit was not operated due to exterior temperature. Manufacturers do not recommend operating units when exterior temperature is below 60 degrees.

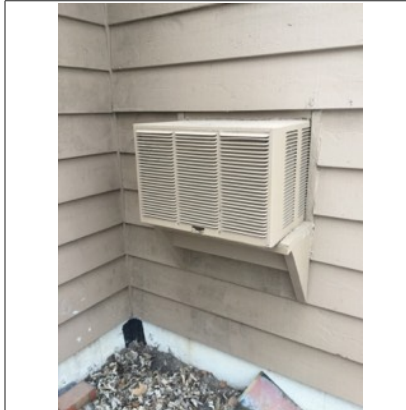
Additional air conditioning unit does not appear to be in use and is older, recommend removing and properly sealing to help reduce energy loss.

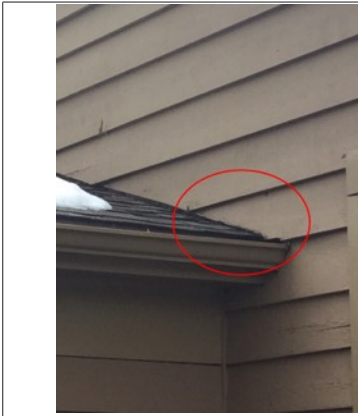
Roofing methods have improved, a kickout flashing is now recommended to prevent isolated areas of water damage to the sidewall above the guttering system.

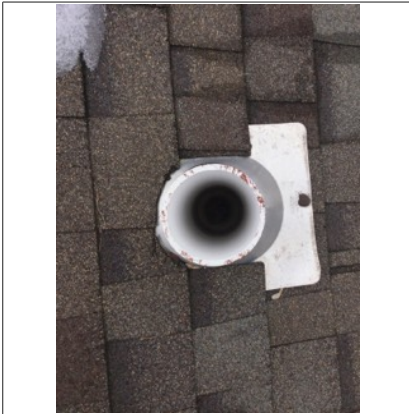
North plumbing vent had  
leaves/debris obstructing a path,  
recommend cleaning as needed

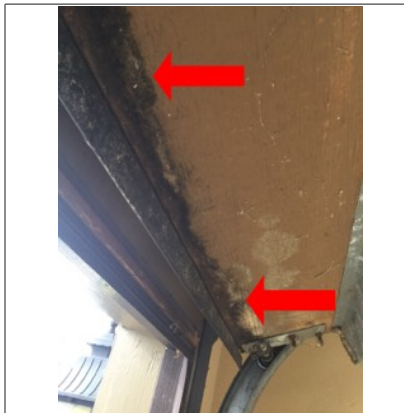
Staining on bottom of wood overhead garage door is common, recommend monitoring and repairing if water damage surfaces.

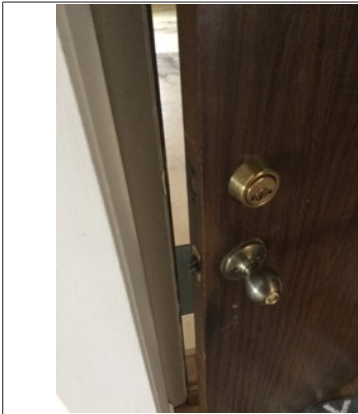
Garage service door to house did not latch properly and requires the keyed lock to latch door, recommend adjusting strike plate and replacing interior keyed lock with a thumb-lock deadbolt.

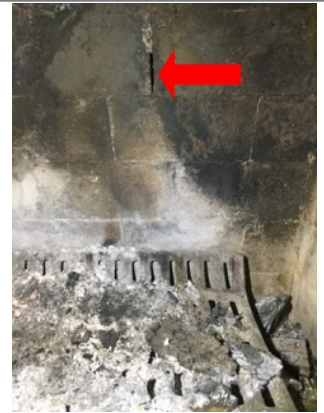
Recommend a qualified chimney specialist seal all gaps in firebrick and clean ash/soot as needed.

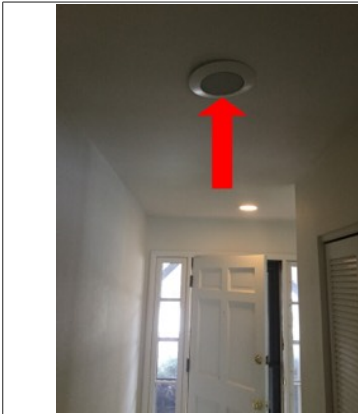
Non-functioning light fixtures were observed during the inspection in one or more areas of the home. It is recommended that all light fixtures be made operational for the final walk-through so that defective lightbulbs can be distinguished from other electrical defects.

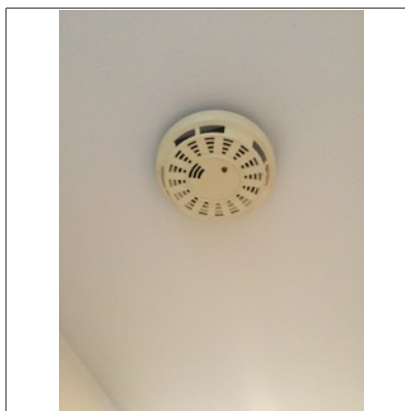
Older smoke detectors does not have modern safety features and there were no visible carbon monoxide detectors

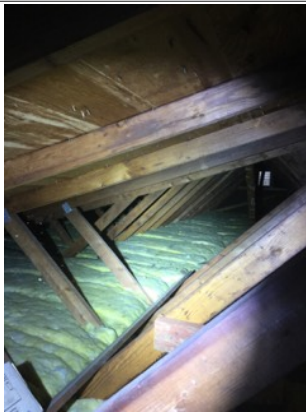
General attic photo  
- The attic insulation in most homes does not meet the Department of Energy's recommended level of R-49 for our area. For maximum energy savings and comfort, this should be remedied with the proper amount of required insulation.

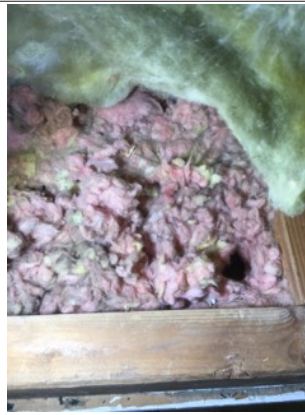
Pest/vermin nesting and droppings were observed in attic.

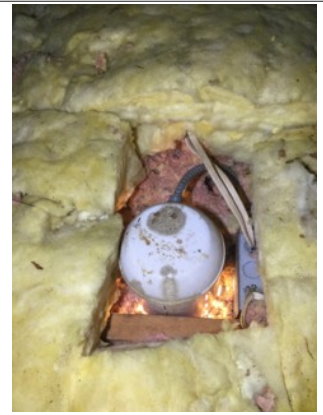
Installed recessed can lights were not rated to be in contact with insulation (IC rated), recommend improving clearances around all recessed light fixtures.

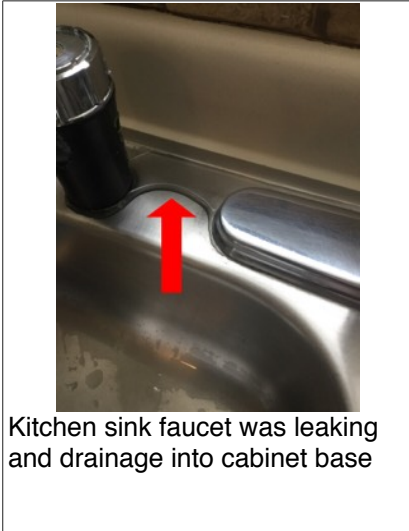
Kitchen sink faucet was leaking and drainage into cabinet base

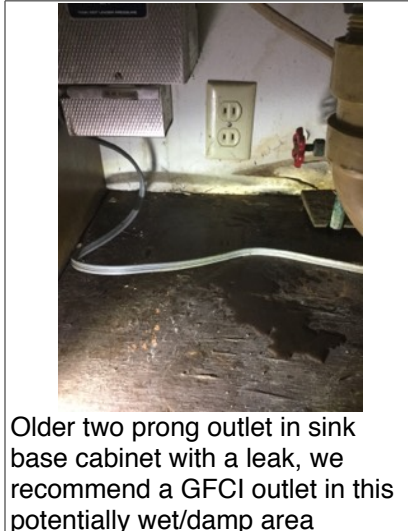
Older two prong outlet in sink base cabinet with a leak, we recommend a GFCI outlet in this potentially wet/damp area

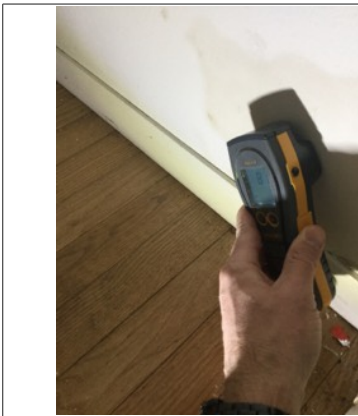
Staining inside adjacent pantry was dry at time of inspection

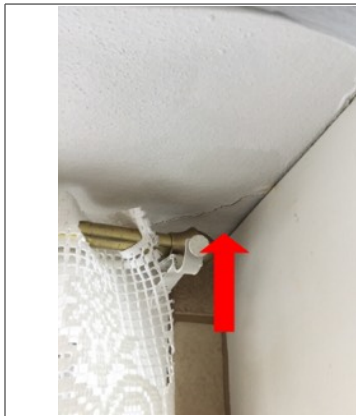
Crack and discoloration on ceiling above kitchen window was dry at time of inspection

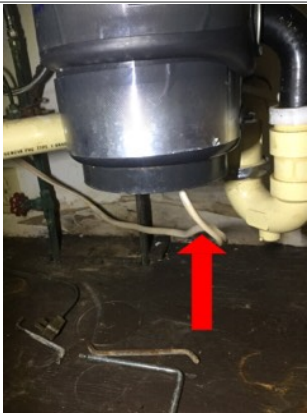
Romex electrical supply wire to garbage disposal was not intended for use outside of a finished wall. Armor shielding should - wiring is susceptible to damage.

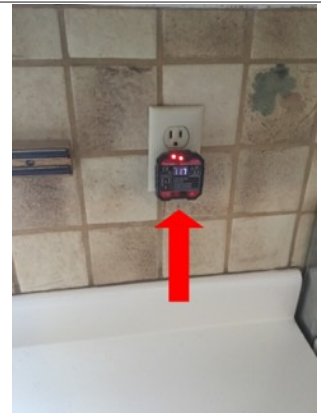
GFCI protection has improved and is now recommended for all outlets above countertop surfaces.

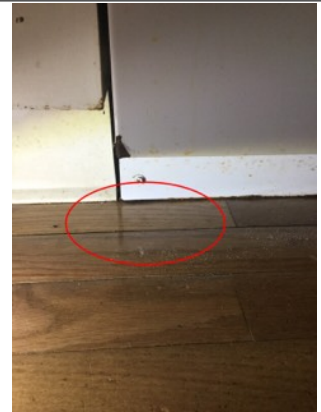
Dishwasher was leaking at corner when operated

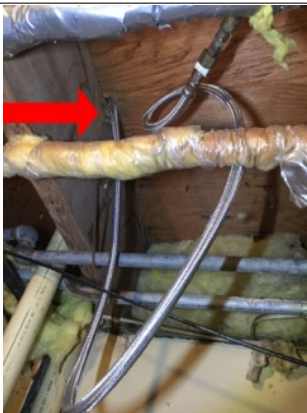
Braided stainless steel hose for dishwasher was in use, manufacturers do not recommend these connectors be installed through floors or walls.

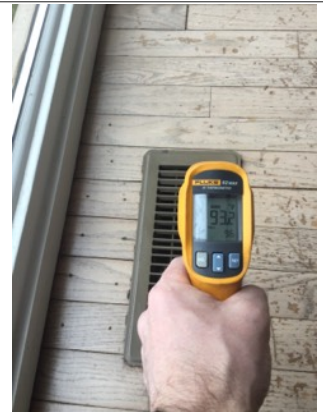
Floor register was outside the similar temperature rise range as other registers in house, a damper on this supply ductwork was partially closed/damaged.

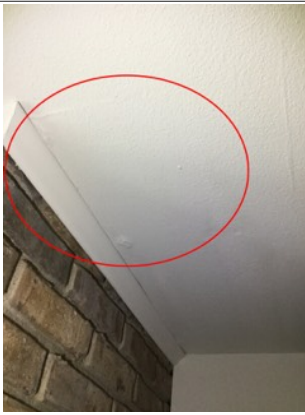
Older water damage on ceiling adjacent fireplace was moisture meter tested and showed no signs of an active leak.

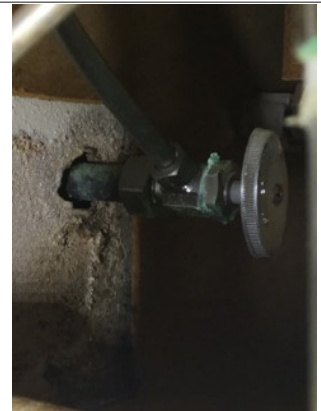
Shutoff valve was leaking, recommend adjusting/repairing as needed.

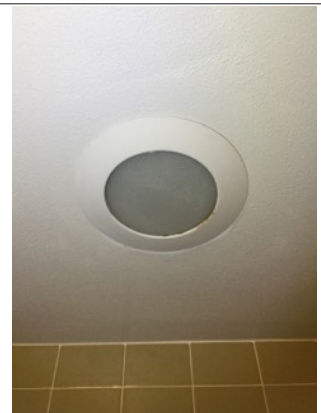
Light fixtures above shower areas in both bathrooms were not rated to be installed in a wet location.

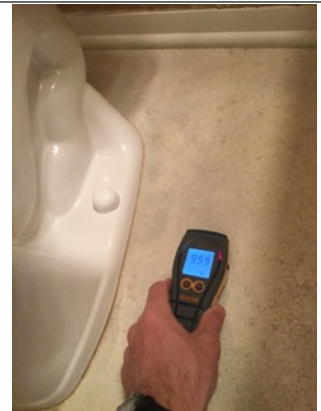
Floor around toilet was moisture meter tested and showed signs of an active leak

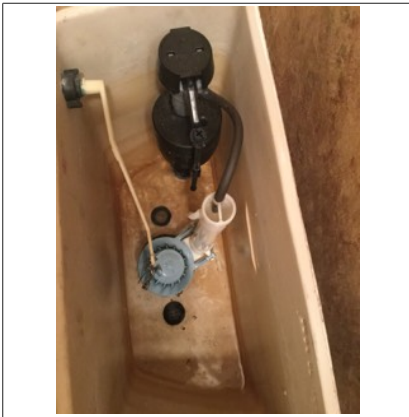
Toilet was recycling water and in need of a flapper adjustment or replacement.

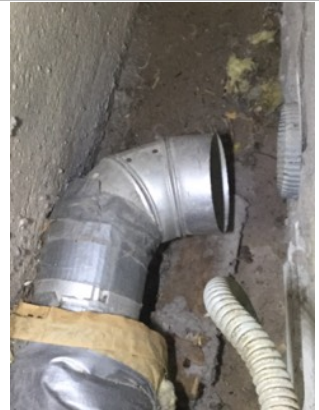
Dryer vent was not connected, recommend proper attachment.

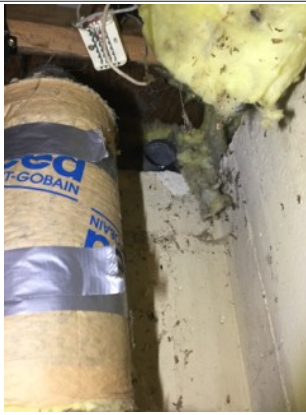
Recommend sealing all open holes to exterior. Pest droppings were observed in the basement area.

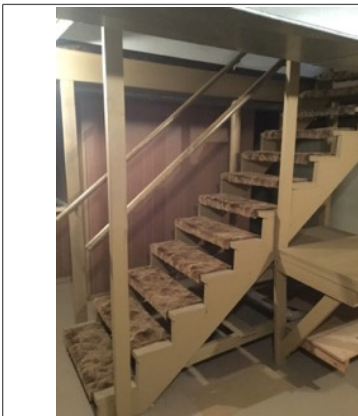
Basement stairway did not have safety guardrails, had open risers and there was no visible light switch on basement level, recommend a qualified person or contractor repair as needed.

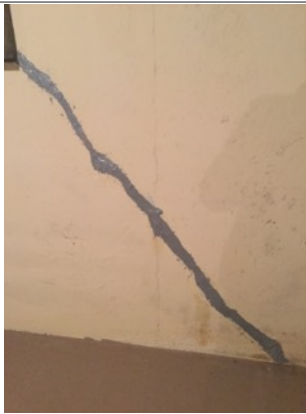
Several foundation cracks have been recently sealed with an epoxy injection.

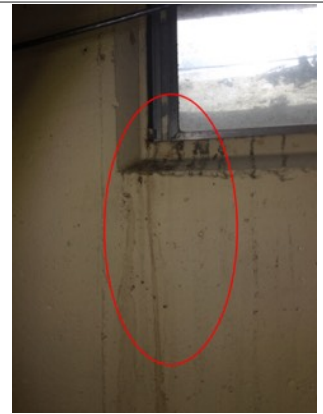
Older water staining below basement windows was evident. These metal windows will have diminishing performance, risk of ongoing deterioration and eventual air and water leakage. Windows should be budgeted for replacement.

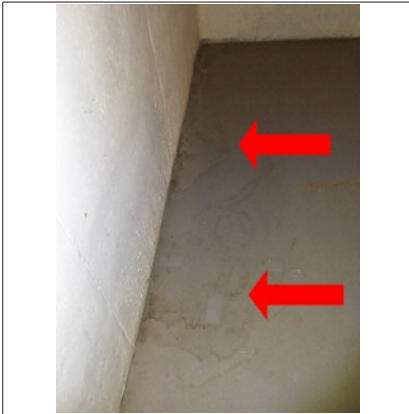
Older watermarks were evident in the North basement area indicating water has entered this area in the past. The basement was dry at the time of the inspection, be sure all exterior grades pitch away from house and extend downspouts as far away as practical.

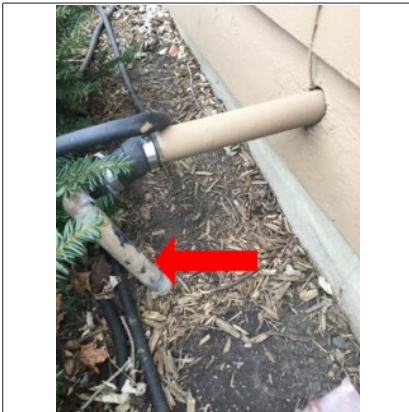
Sump pump discharge pipe reduces in diameter, is below grade and exterior termination point was not visible, recommend occasionally monitoring for proper water runoff.

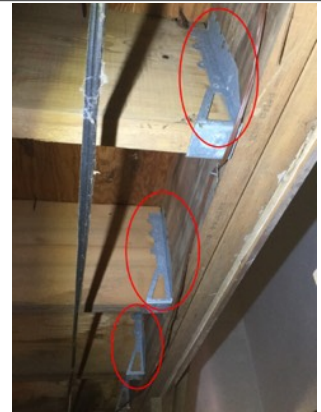
All joists along basement stairway were missing required nails.

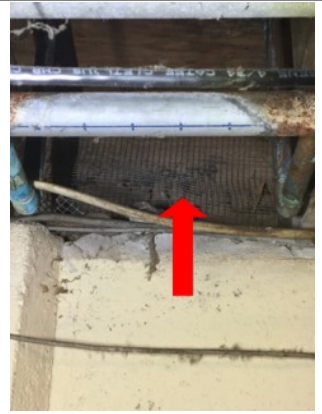
A draft with previous screen was evident below kitchen area. The deck limited a visual inspection of this exterior area. Pest dropping were in this basement area and leaves/foliage, recommend sealing.

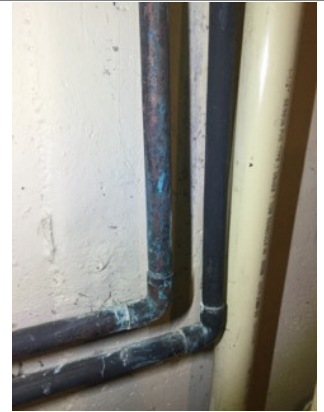
A black coating was observed on a majority of the copper water supply piping. This is common for homes with well water or homes with previous well water supplied and high levels of iron within the water. The black coating indicates elevated levels of sulfur. The homes water supply is currently connected to the city's water supply.

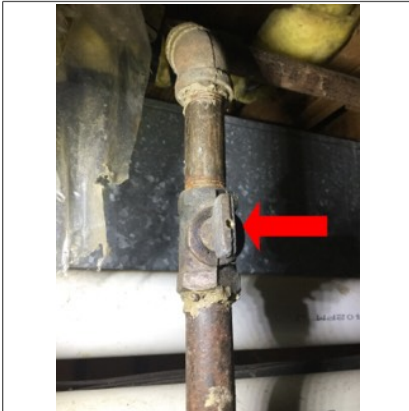
Consider upgrading the difficult to operate, older brass gas shutoff valve for water heater with an industry standard ball valve.

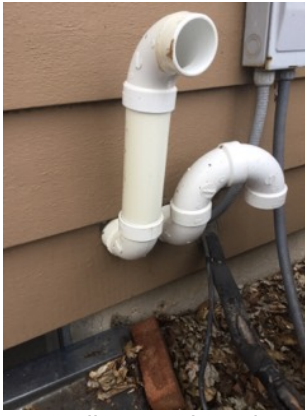
Water gurgling was heard at exhaust pipe indicating condensation is trapped within pipe and a leak was observed at exterior elbow, a routine maintenance evaluation is recommended.

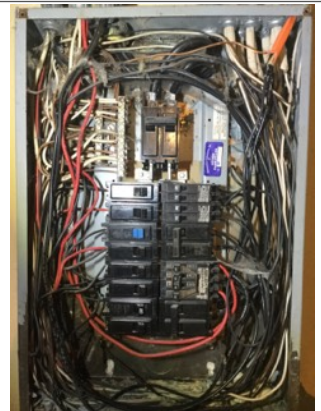
Electrical panel with cover removed  
- There are no spare circuit breakers available in the electrical panel. Good electrical practices recommend a larger panel or subpanel of sufficient capacity be considered to provide future expansion and unforeseen electrical demands.

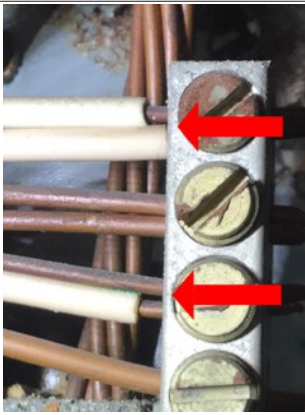
Electrical safety has improved, multiple neutral (white) wires are no longer recommended to be installed under the same screw and ground (bare) wires are no longer recommended to be installed under the same screw as neutral wires
