## Home Inspection Report

9776 Heavenly Lane, Mequon , WI 53092

Saturday, March 10, 2018

200204

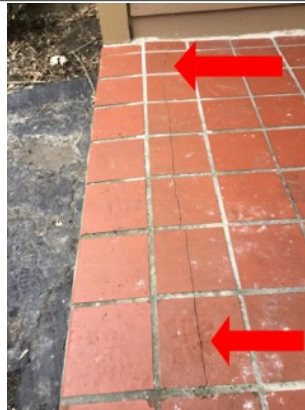
Porch floor had some settlement with a crack.

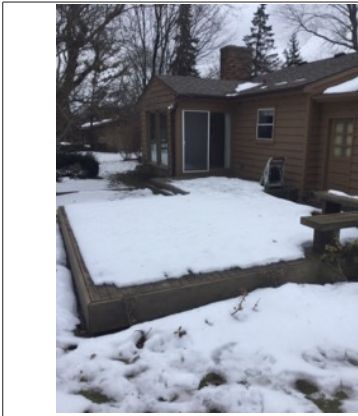
Majority of deck was snow covered and not visible

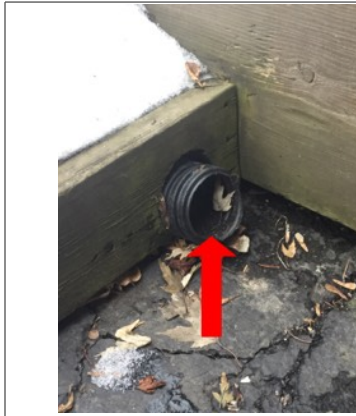
Older drainage piping below deck does not appear to be in use

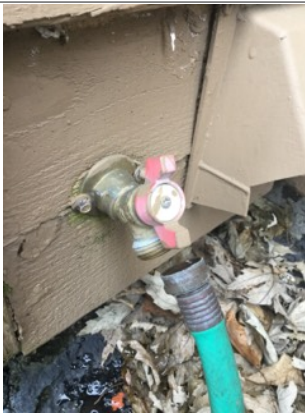
-Hose bibs were not on (winterized) and not evaluated.  
-Consider upgrading hose bibs to a newer style with modern safety features

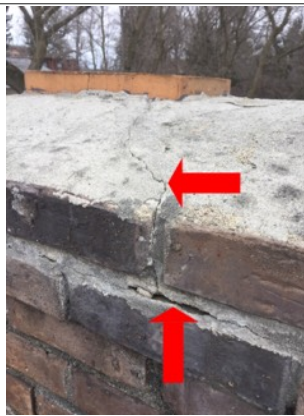
Missing/loose mortar in the brick joints and cracked chimney cap - recommend tuckpointing/sealing maintenance

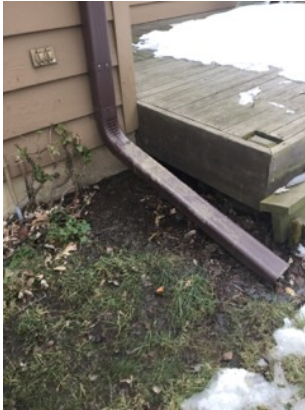
Recommend installing downspout extensions to allow proper water drainage as far away from house as practical to prevent roof water from collecting against the house and seeping into the lower level. Water staining was observed in the basement area below this saturated exterior downspout area.

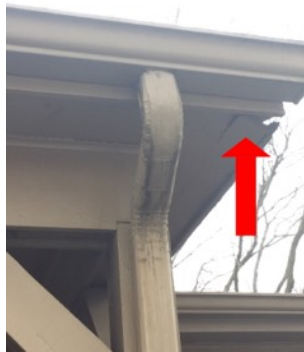
Gutters are leaking at the seams with visible water damage - recommend repair

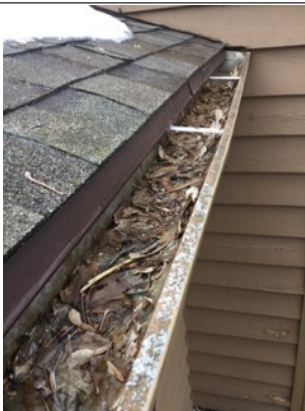
Portions of the guttering system require cleaning now and at least every spring and multiple times during the fall in the future.

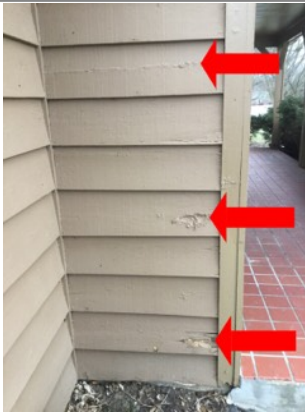
The exterior wood of the house has peeling paint and isolated areas of wood rot. This may be an indication of delayed or poor maintenance; there may be additional areas that need repair. The amount and depth of any moisture penetration is not observable until damaged areas are removed.

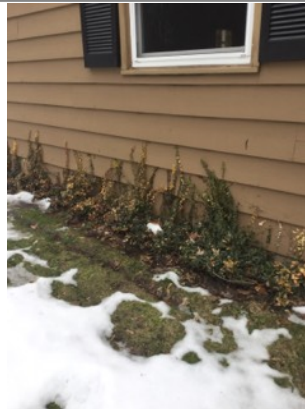
Vines/foliage may damage the siding and is an inviting environment for moisture and insects, consider removing.

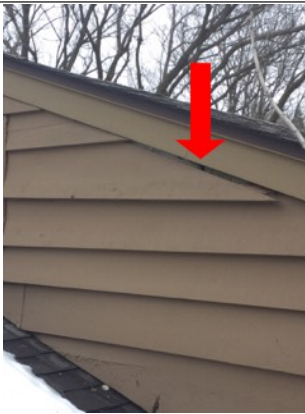
Bowed and loose wood siding, replacement is recommended

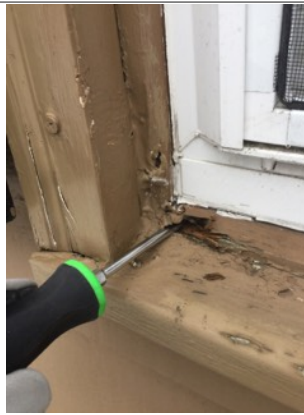
One or more areas of the home's trim had some water damage and/or deterioration increasing the potential for water intrusion and moisture related damage to adjacent components and interior finishes, recommend repairing/replacing all damaged areas as needed and routine painting maintenance. Consideration should be given to upgrade the exterior trim components with those fabricated of PVC or a composite material, or the like, due to those materials' superior moisture resistance and reduced maintenance requirements.

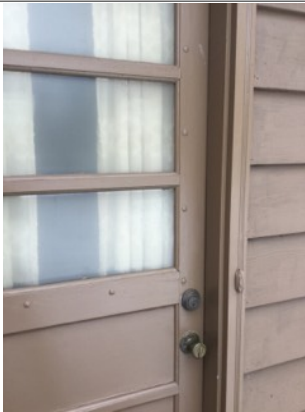
Door safety has improved, tempered safety glass is now recommended in all doors with glass openings larger than a 3" sphere.

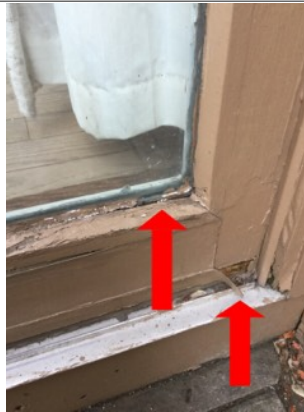
Peeling paint on base of rear sliding door, sliding door should be budgeted for replacement

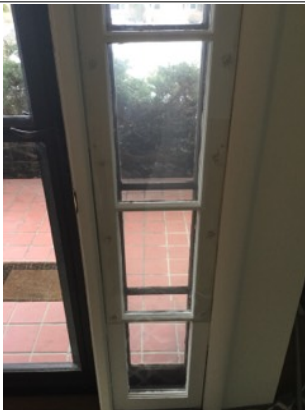
Plexiglass was installed on sidelights adjacent main entrance door

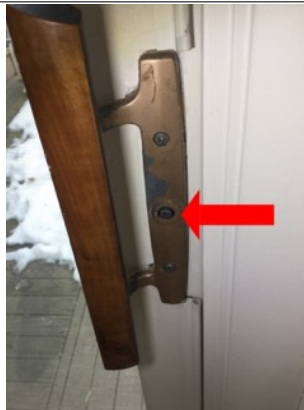
Rear sliding door locking mechanism was missing, a secondary wood piece was in use for locking purposes.

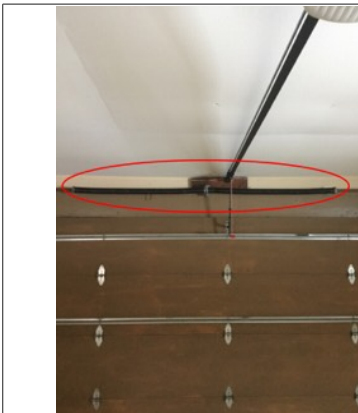
Overhead garage door spring(s) were in satisfactory condition at time of inspection.

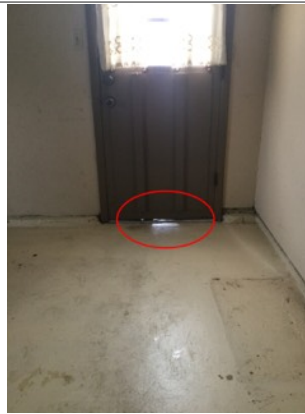
Daylight was observed around exterior service door, recommend improving weatherstripping and/or threshold as needed to prevent a path for insects/pests and to also help reduce energy loss.

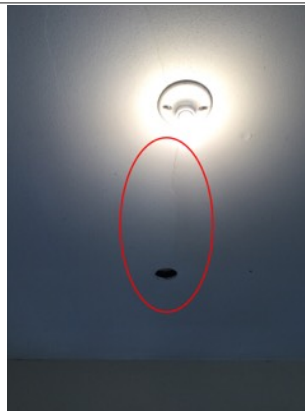
Recommend sealing all holes in the ceiling to complete the fire separation wall.

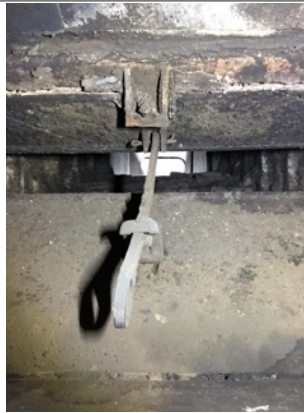
When viewed up from firebox, flue had some creosote buildup, a routine sweep is recommended

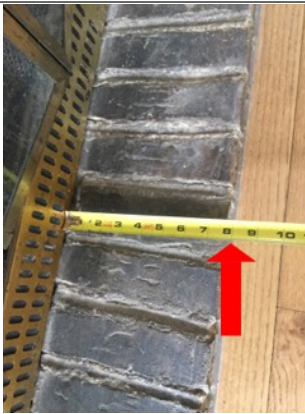
Natural fireplace safety has improved, a minimum depth hearth extension of 16" is now recommended due to the possibility of a log roll out. Placing a fire retardant rug is a common repair.

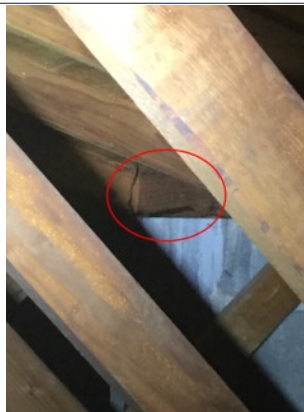
Older staining adjacent chimney with no signs of an active leak

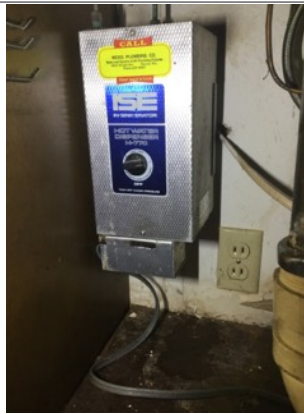
Older hot water dispenser was not in use and not evaluated. These older units are commonly abandoned due to leakage issues.

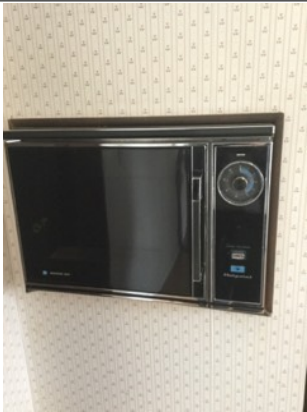
In-wall stove was not in use and not evaluated. We recommend removing due to age and lack of modern safety features

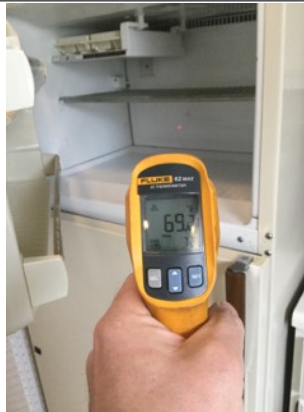
Refrigerator was not on at time of inspection and not evaluated

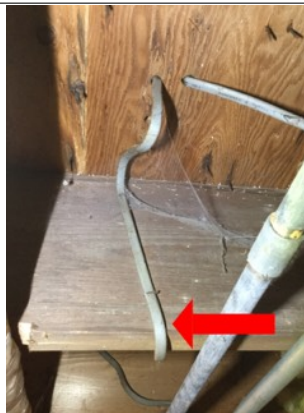
Wiring for dishwasher was not installed/protected properly and appears to be an amateur installation.

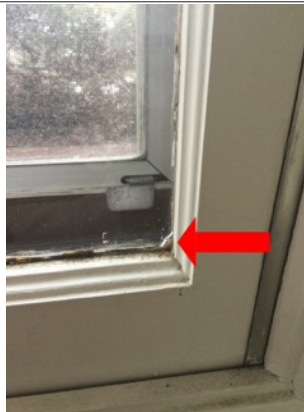
Cracked glass pane and lower sash was loose to frame

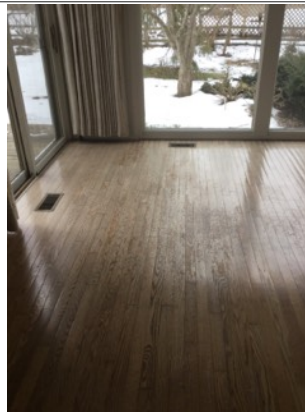
Ultraviolet sunlight damage was observed on hardwood floors.

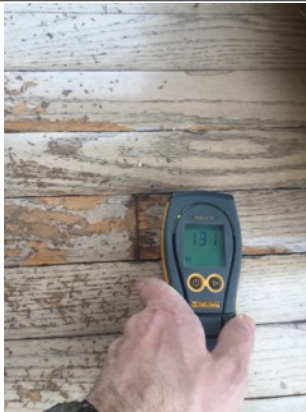
Staining on floor adjacent larger North window was dry at time of inspection. Exterior rot was observed around windows and we can not rule out possible continued interior damage until window damage is repaired.

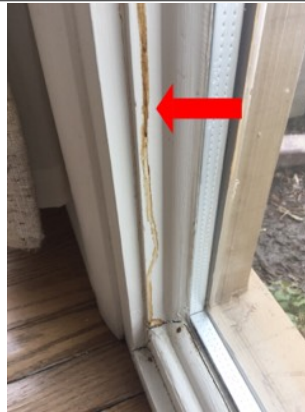
Water staining on window frame.

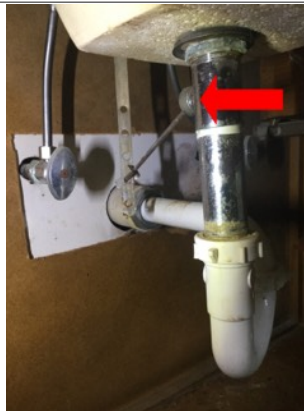
Stopper assembly was not functional with a leak at connection

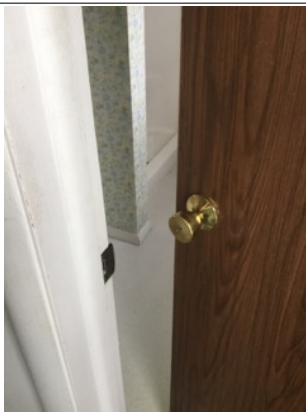
Door did not latch properly, recommend adjusting/repairing as needed

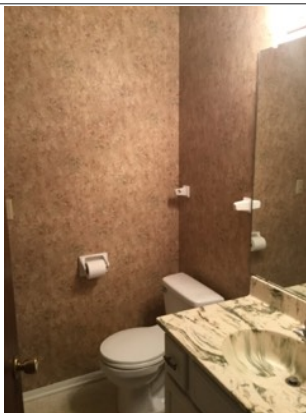
Bathroom (2)  
- Bathroom outlet was not GFCI protected

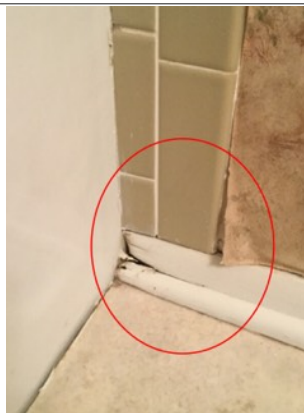
Water damage was evident adjacent bathtub area, recommend repairing as needed.

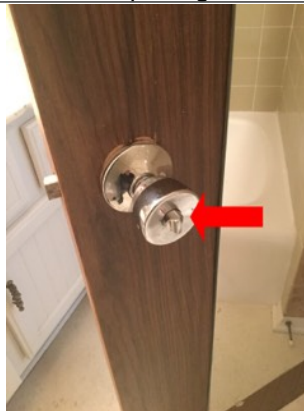
Door did not lock properly

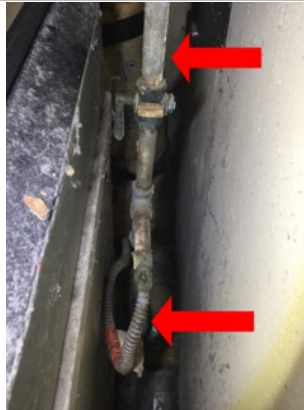
-Galvanized piping was installed for gas piping and is no longer recommended, black iron is now an industry standard material.  
 Piping was also loose to wall, recommend proper attachment.  
 -Recommend replacing older flexible gas connector with a stainless steel connector.

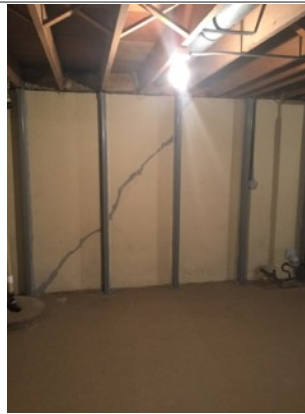
Some walls in basement have been reinforced/stabilized with steel beams. This is a common repair for excess moisture expansion in adjacent soil due to frost cycles. Recommend consulting with seller for additional information and/or possible warranty.

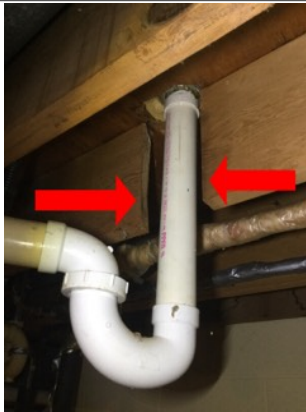
Joist was improperly cut without reinforcement or bracing with no signs of failure, "sistering" is a common repair.

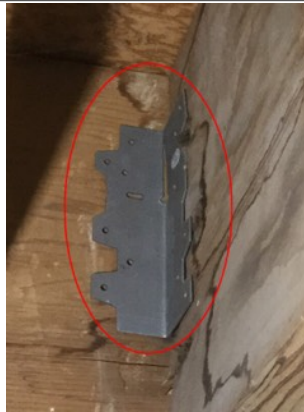
Numerous joist hangers were missing most or all of the required nails, recommend installing. Picture is joist adjacent fireplace.

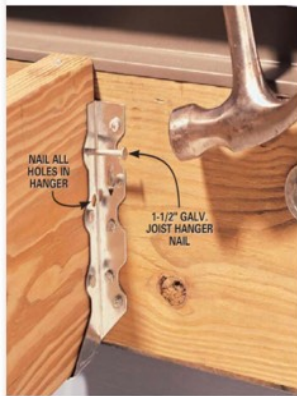
Joists do not have their rated load capacity until all holes in joist hanger are nailed.

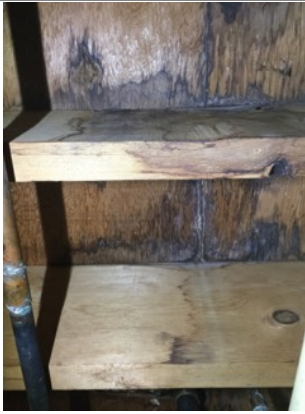
Chronic water staining was observed below both bathrooms. Toilet was leaking at time of inspection however, we can not guarantee an additional leak is hidden below an adjacent fixture.

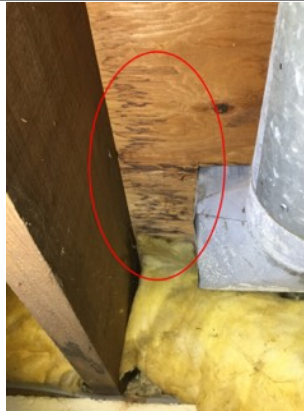
Water staining below North Family Room Windows. Wood rot was observed on exterior of this location.

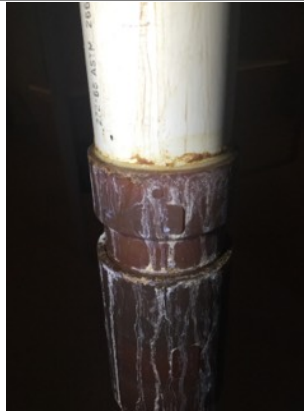
Drainage pipe below bathrooms has signs of chronic and active leaks

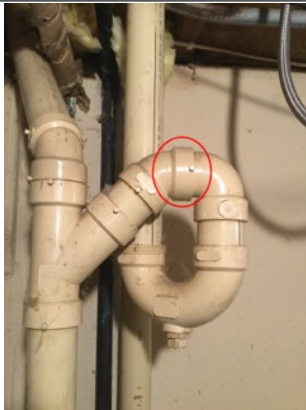
Drain for dishwasher is below kitchen in laundry room. Dishwasher drains are commonly connected to the kitchen sinks drainage pipe. This configuration potentially allows sewer gases into the dishwasher. A minimum 3" length horizontal pipe is recommended to prevent water siphoning through trap.

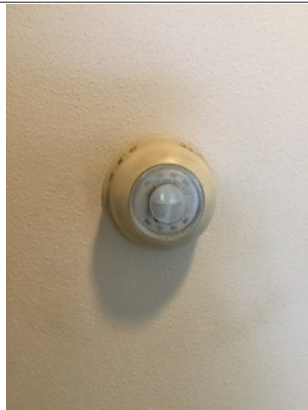
Consider upgrading thermostat to a newer programable style to help reduce energy loss.

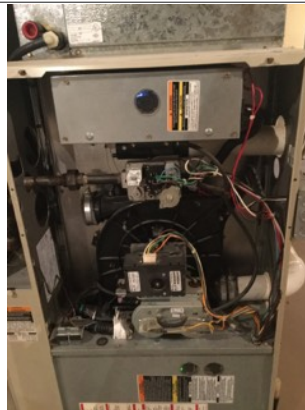
Furnace with cover removed. Furnace operated as intended at time of inspection.

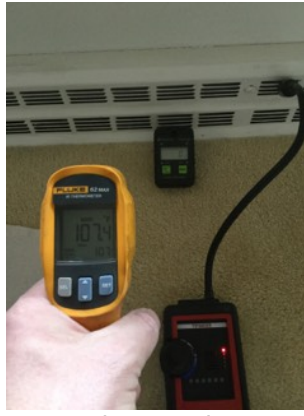
When tested at a register, temperature rise was within the recommended range and two gas detectors displayed a zero reading.

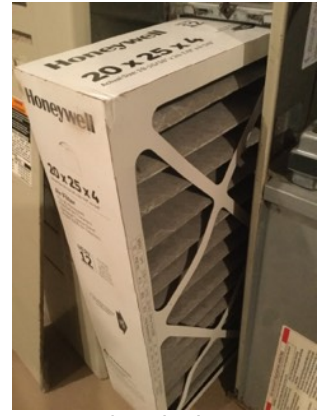
**Filter** ☒ Standard ☐ Electrostatic ☐ Satisfactory ☒ Needs cleaning/replacement ☐ Missing

Recommend replacing 20x25x4 furnace filter

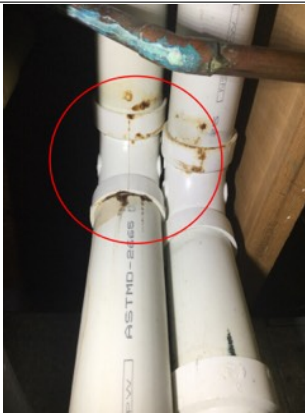
**Flue piping** ☐ N/A ☐ Satisfactory ☐ Rusted ☒ Improper slope ☐ Safety hazard ☒ Recommend repair/replace

Furnace exhaust pipe has evidence of a leak. Condensation appears to be trapped indicating an improper slope, recommend further evaluation

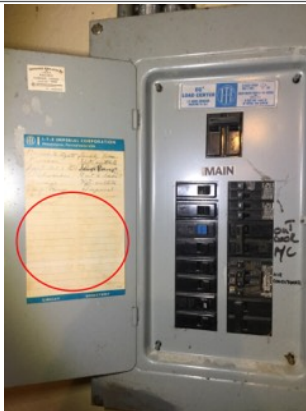
Electrical panel was not properly labeled, recommend a qualified person or contractor label every circuit as needed so power can be turned off in a possible emergency.

- Typical design life of circuit breakers is between 30-35 years. The installed electrical panel/system is older than 35 years old and we recommend consulting with a licensed electrician for evaluation to determine the need for a system upgrade.

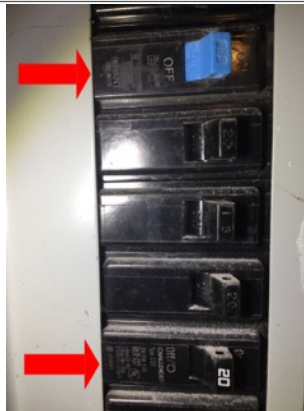
☒ Dissimilar Circuit Breakers ☒ Recommend Separating Ground And Neutral Wires

Electrical panel manufacturers recommend their brand specific (ITE) circuit breakers be installed within the panel to ensure the breakers are seated properly, reducing the risk for arcing and related hazards. Some installed circuit breakers were a dissimilar (Bryant and Challenger) than the electrical panel was designed for, further evaluation by a licensed electrician is recommended.

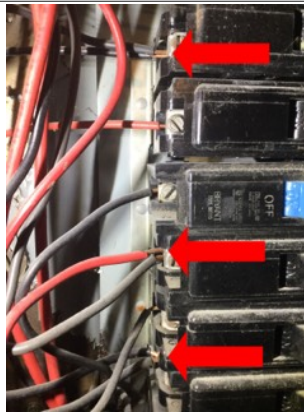
Several (4) circuit breakers were double tapped. A double tapped breaker is when two or more wires are installed in a single circuit or under a single lug that was designed for one wire - not making proper contact and potentially overloading the circuit.

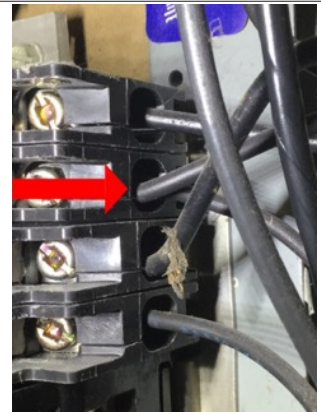
Double tapped circuit breaker
